Comparative Landscape Photographs of the Lonely Dell Area and the Mouth of the Paria River

By Robert H. Webb and Richard Hereford

Pamphlet to accompany
Geologic Investigations Series I-2771

2003

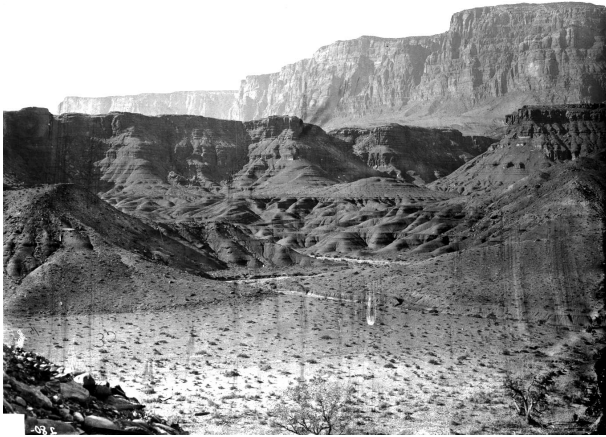
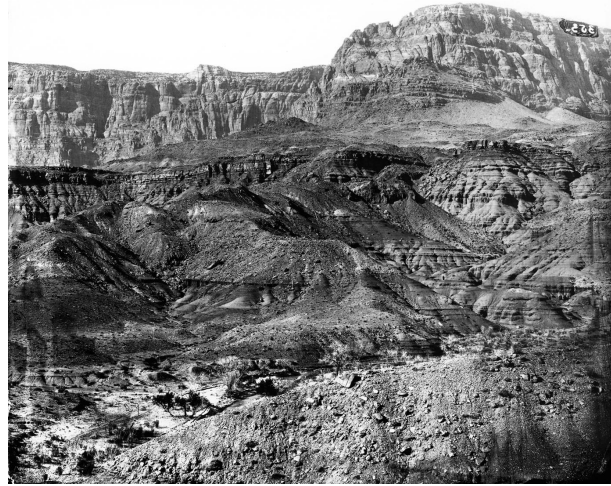
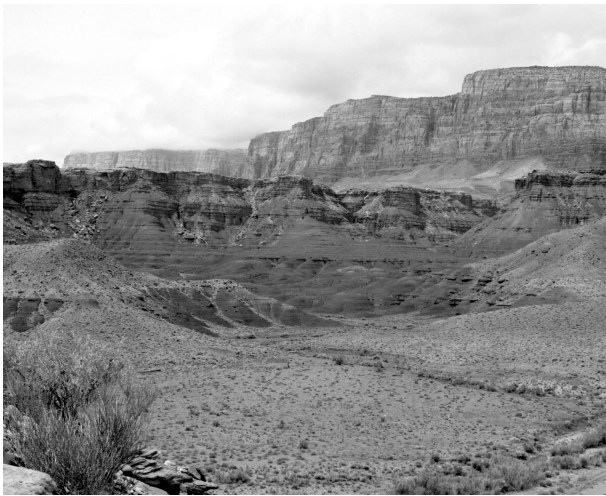
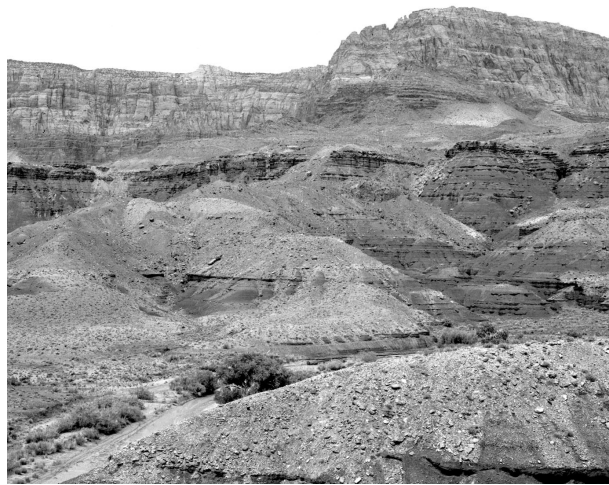
Photograph site 1.

1872, A. In this first of four photographs in a panorama from south to north, William A. Bell of the Wheeler Expedition photographed the geology of the Paria Canyon and the Lonely Dell reach of the Paria River. This view in the panorama faces southwest across the Paria River into a tributary canyon. This channel appears barren, as if a recent flood had scoured sediments from the bed and banks. The Paria River is barely discernable, with only two small cottonwood trees (*Populus fremontii*) visible on the right bank. The photographs must have been taken during the winter months because the cottonwoods are leafless. **May 25, 1992, A.** The tributary channel is distinct in the 1872 image but is obscured by shrubs in the 1992 image. The low cutbank in the lower right was incised after 1872 and before deposition of the modern alluvium. The modern terrace (unit mt) of the Paria River is covered with willow (*Salix exigua*), native shrubs, and tamarisk (*Tamarix* sp.), a non-native species that was introduced into the watershed about the time this photograph was taken. The cottonwoods have disappeared from the view. Saltbushes (*Atriplex confertifolia* and *A. canescens*) and snakeweed (*Gutierrezia sarothrae*) appear on the midground terraces and modern terrace (unit mt). Several large cobbles remain in the foreground. **1872, B.** Of the four views, the Paria River channel is least obstructed by the Pleistocene terrace (unit gvc) in this view to the west-southwest. A wagon track, probably used by John D. Lee, appears on the settlement-age floodplain on the lower left. Scattered, leafless cottonwoods occupy both banks; the dark trees appear to be junipers (*Juniperus osteosperma*). The right channel margin has a steep, nearly vertical bank of perhaps 0.6 to 1.0 m high. **May 25, 1992, B.** The geological formations shown in the 1872 photograph appear more subdued and rounded in this view because of cloud cover. The steep slopes of the Pleistocene terrace have eroded, removing many of the rocks that were perched

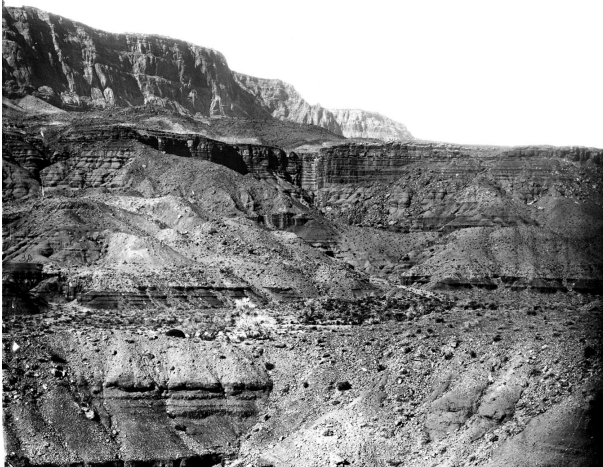
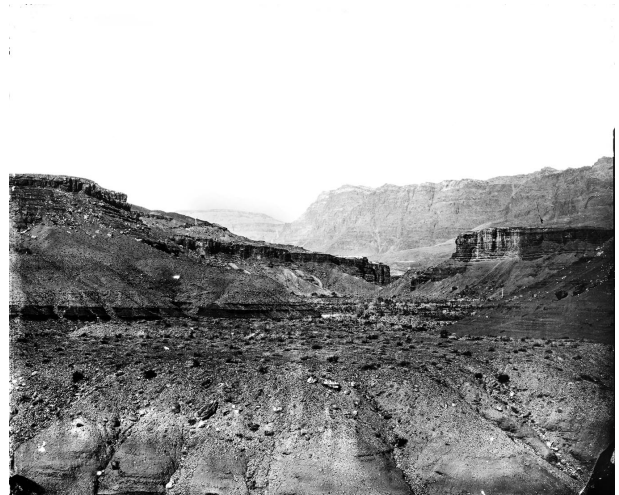
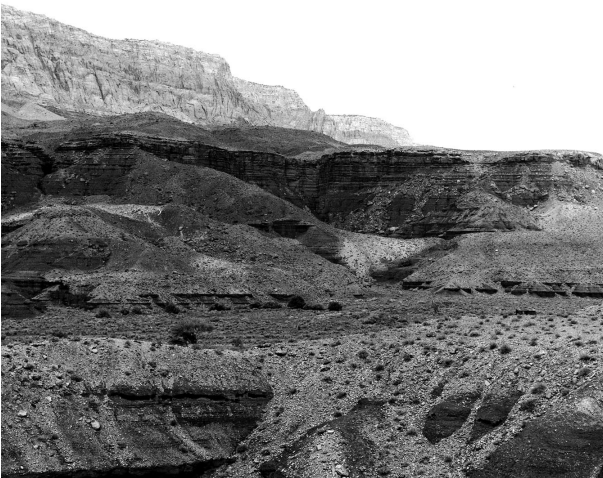
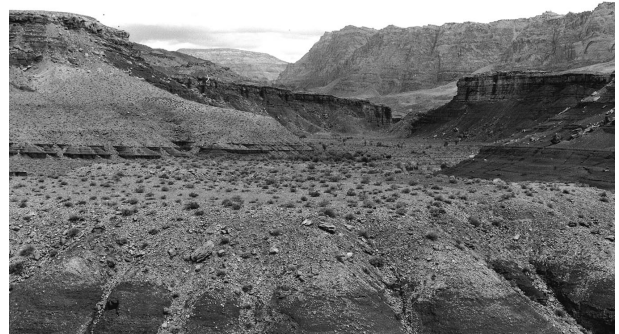
Photograph site 1.—Continued

there. In the lower left, the modern terrace (unit mt) has replaced the former settlement-age floodplain. The original cottonwoods are gone from the view, replaced by tamarisk and willows with scattered native shrubs; one cottonwood appears in the lower center. An irrigation ditch was constructed after 1872 above the right bank (facing downstream). **1872, C.** In this view of the panorama, Bell captures details of the Pleistocene terrace (unit gvc) in the foreground, a small portion of the Paria River in the middle, and the cliffs at the base of the Paria Plateau in the background. The view is to the west-northwest. Small cottonwood trees line the channel of the Paria River at the center and large shrubs, possibly greasewood (*Sarcobatus vermiculatus*) dot the settlement-age floodplain. **May 25, 1992, C.** Although some of the rocks on the foreground terrace have slid downslope, many are in the same place. The cottonwoods are gone and tamarisk and willow are scattered on the modern terrace (unit mt). **1872, D.** This view toward the north-northwest shows the channel of the Paria River upstream from the Lonely Dell Ranch and the Pleistocene terrace (unit gvc) on the east side of the channel. Scattered shrubs, most of which are shadscale (*Atriplex confertifolia*), are on the surface of the terrace. In the middle distance looking over the terrace in the foreground, the Paria River is lined with small cottonwood trees. **May 25, 1992, D.** In the foreground, some rocks on the top and sides of the Pleistocene terrace (unit gvc) remain in the same place, as well as some shrubs that have persisted despite heavy grazing in the area in the intervening 120 years. The riparian vegetation along the channel in the distance is now mostly tamarisk. Cottonwoods are no longer present in this view, although they remain in this reach. (1872 photographs by William A. Bell, courtesy of the National Archives, 280, 353, 265, 267; May 25, 1992 photographs by Robert H. Webb, U.S. Geological Survey, Stake 2254d, 2254c, 2254b, 2254a.)

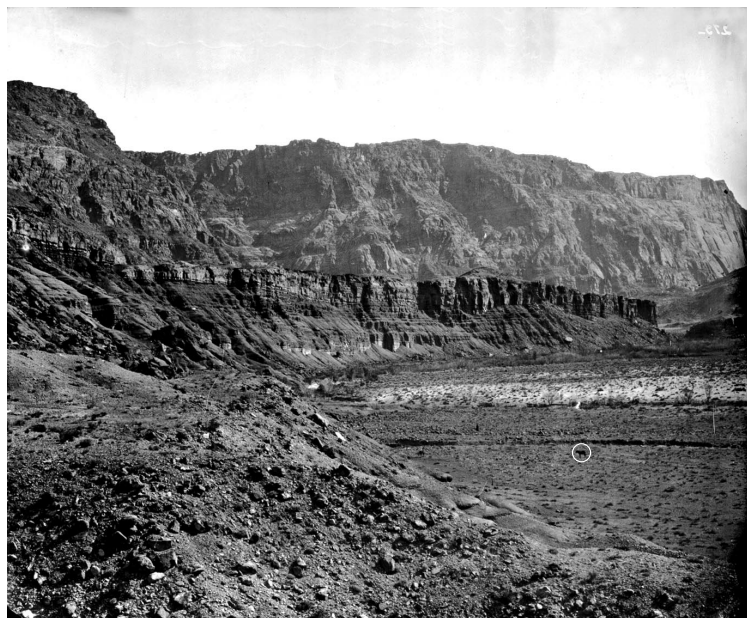
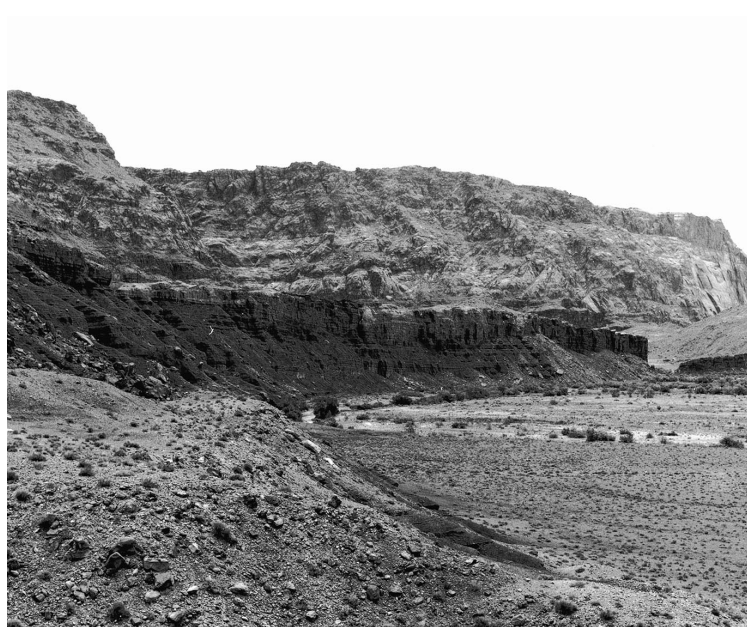
Photograph site 2.

1872, A. To get a better view of Paria Canyon upstream from Lonely Dell Ranch, William Bell moved his camera slightly on the Pleistocene terraces and took panning views downstream. In this horizontal format view, Bell shows two levels of Pleistocene terraces (left foreground; units gvc and gvd) overlying the Moenkopi Formation (unit $\overline{\text{Fm}}$). Cottonwood trees grow along the channel, which flows right to left across the midground, then turns to join the Colorado River. In the distance, the channel of the Paria River is obscured behind a dense grove of willows. A solitary horse (circle) is on the floodplain at right center. (*Photograph by William A. Bell, courtesy of the National Archives, 273.*) **May 25, 1992, A.** Many of the rocks on the prehistoric debris fan (unit dfp) in the foreground are in the same place 120 years later. The channel of the Paria River appears to be wider and deeper, and the amount of riparian vegetation appears to have decreased in the view. The prehistoric terrace (unit pt) beyond the Paria River channel was intensively farmed in the late 1800s to early 1900s; it appears barren compared with the vegetation cover present in 1872. Tamarisk appears to be far more abundant than native willow, and cottonwood appears much larger although less numerous than in 1872. (*Photograph by Robert H. Webb, U.S. Geological Survey, Stake 2255a.*)

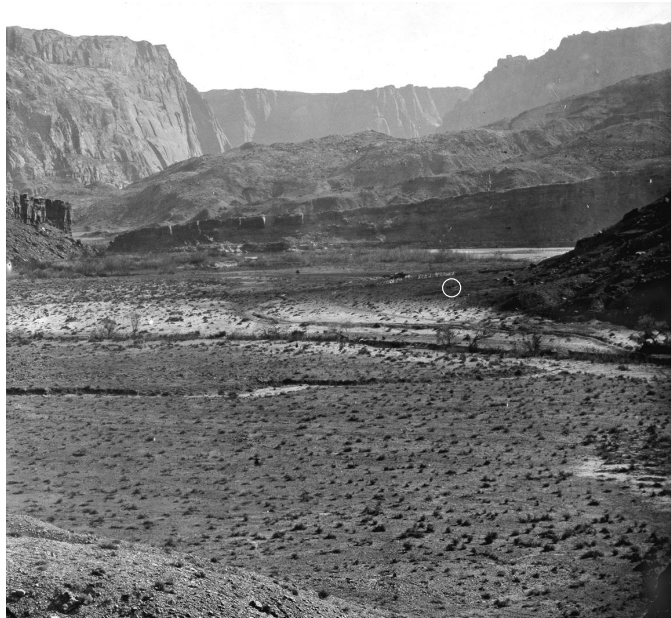
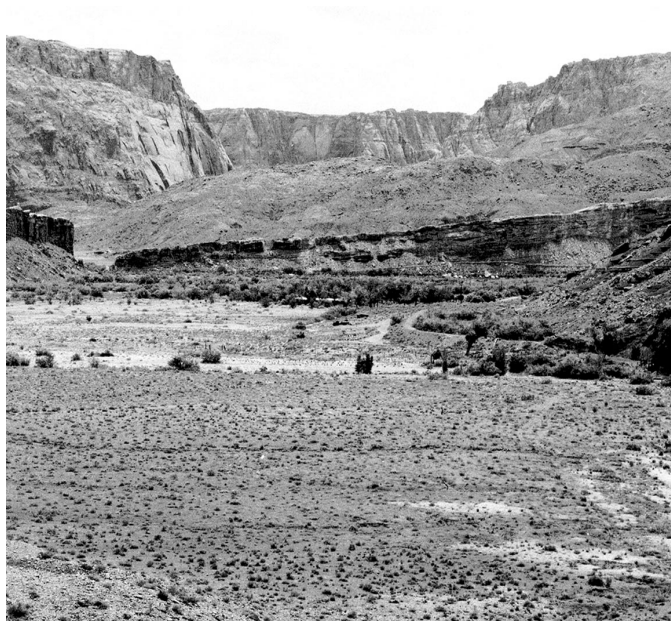
Photograph site 2.—Continued

1872, *B*. In this vertical-format downstream view, Bell's photograph captures the image of the Paria River as it leaves the west bedrock wall and crosses the valley (right to left). John D. Lee's house, built the year before Bell arrived, appears as a low shack in the right center (circle). An irrigation ditch on the prehistoric terrace (unit pt) appears prominently in the view. It was built by John D. Lee and leads upstream to his first dam just off the right margin of the photograph. The channel of the Paria River, lined with small cottonwoods and shrubs that are probably seep willow (*Baccharis* sp.), appears incised below the prehistoric terrace. A gully on the prehistoric debris fan (unit dfp) in the midground appears scoured as if a recent flood had eroded the channel. (*Photograph by William A. Bell, courtesy of the National Archives, 589.*) **May 25, 1992, *B*.** The modern terrace (unit mt) of the Paria River channel, marked by scattered cottonwood mixed with tamarisk, appears to be wider than the settlement-age floodplain of 1872. Lee's house has been replaced by the Lonely Dell compound, which consists of a number of buildings, orchards, and cultivated cottonwood trees. A permanent road and two irrigation ponds were constructed in the intervening years. The gully across the midground appears subdued and is partly filled with sediment. (*Photograph by Robert H. Webb, U.S. Geological Survey, Stake 2255c.*)

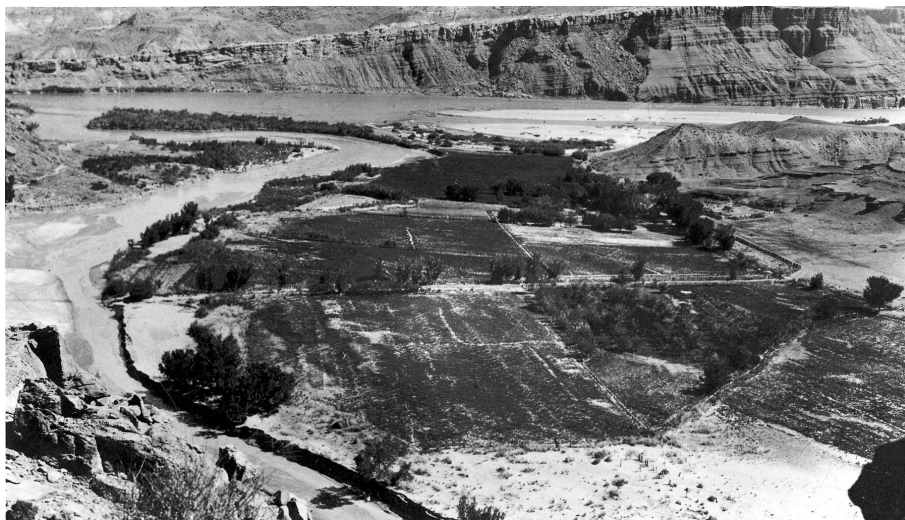
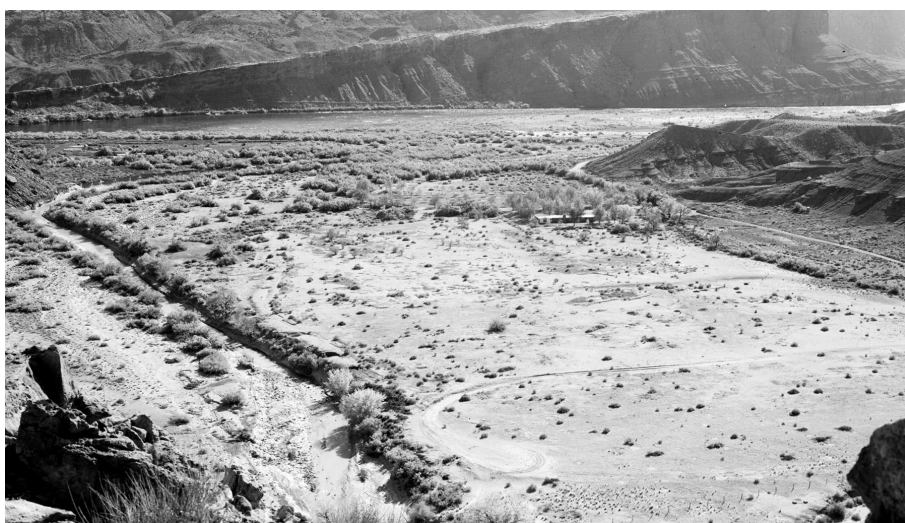
Photograph site 3.

1910. Charles H. Spencer attempted to mine the Chinle Formation for gold beginning in 1910. Albert Jones, who worked for Spencer, took this south-facing photograph of the Lonely Dell Ranch and Paria River delta. At the time of the photograph, the mouth of the Paria River was on the upstream side of the delta. The channel is wide and relatively deep, and the vertical banks may be the legacy of the 1909 flood (fig. 4 and table 2 on map) of the Paria River. With the exception of the delta area, the channel is free of riparian vegetation, and only scattered cottonwoods appear along the banks. On the delta, native willow and arrowweed (*Tessaria sericea*) dominate the floodplain, which is the younger terrace (unit yt) of the Colorado River. The photograph was taken during the annual flood of the Colorado River (May–June), which is backed up into the Paria River. The center of the photograph shows the fields and orchards of Lonely Dell Ranch. The road crossing the fields led to the Paria River crossing and Lees Ferry. (Photograph by Albert H. Jones, courtesy of the P.T. Reilly Collection, Cline Library, Northern Arizona University.) **November 11, 1999.** The channel of the Paria River has narrowed, shifted, and aggraded with deposits of the modern alluvium, as this photograph and several that follow show. Almost directly below the camera position, a gaging station was installed in 1923 to record streamflow of the Paria River. Willow and tamarisk form a nearly continuous line on both banks; a few new cottonwood trees have become established. Willow is now scarce in the delta area, replaced by tamarisk and arrowweed. One Mormon tea bush (*Ephedra torreyana*) persists in the rocks at lower left. (Photograph by Robert H. Webb, U.S. Geological Survey, Stake 3989.)

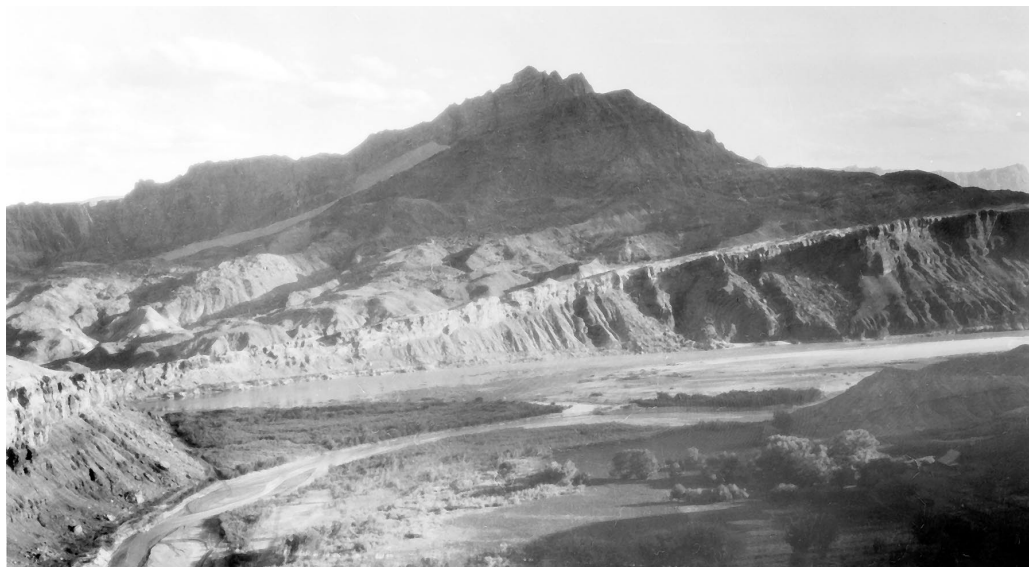
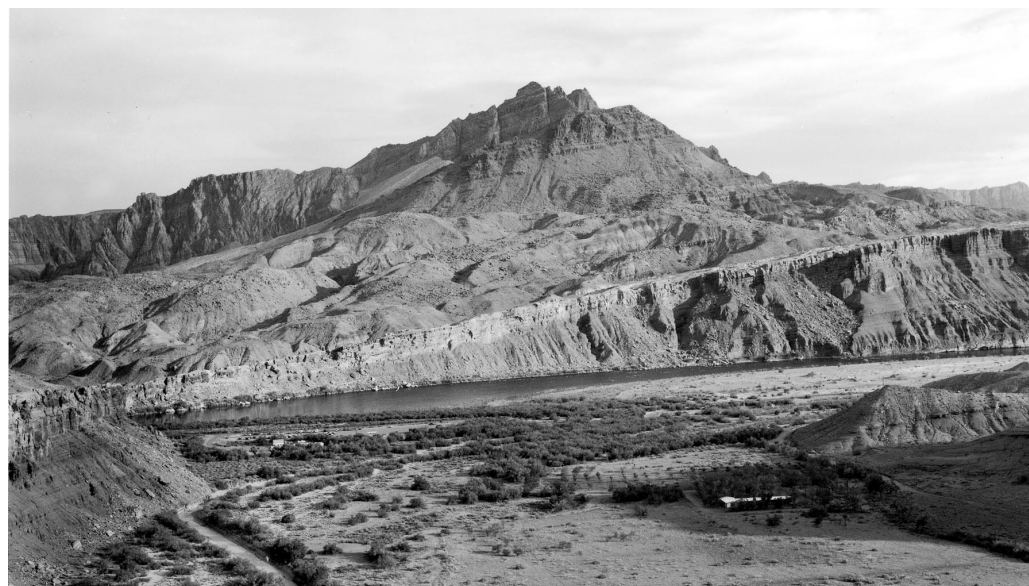
Photograph site 4.

1921. Taken by the Kolb brothers, this view is from a similar vantage point as photograph site 3. In 1912, the mouth of the Paria River shifted to below the delta; by 1921 the upper channel was silted in partly by deposition of the alluvium of the younger terrace (unit yt) and was covered by a dense thicket of willow and arrowweed. As seen in the lower left, the channel of the Paria River shifted to the southeast since 1910, eroding Holocene talus (unit ts) and the intermediate terrace (unit it), continuing a pattern that began after 1872 (see Timothy O’Sullivan’s 1873 photograph, photograph site 11, and Franklin A. Nims 1889 photograph, photograph site 12). Lonely Dell Ranch is in the shadows at lower right. (*Photograph by the Kolb Brothers 568-676, courtesy of the Cline Library, Northern Arizona University.*) **May 5, 1994.** As shown in photograph site 3, the channel of the Paria River has narrowed through deposition of the modern alluvium; a dense stand of tamarisk and willow lines both banks. The difference in stature between native willow and non-native tamarisk is particularly apparent in a comparison of the left midground, where the Paria River channel trends away from the eastern cliff. The buildings just above this area are National Park Service facilities constructed on the younger terrace (unit yt) since 1963. (*Photograph by Dominic Oldershaw, Stake 2854.*)

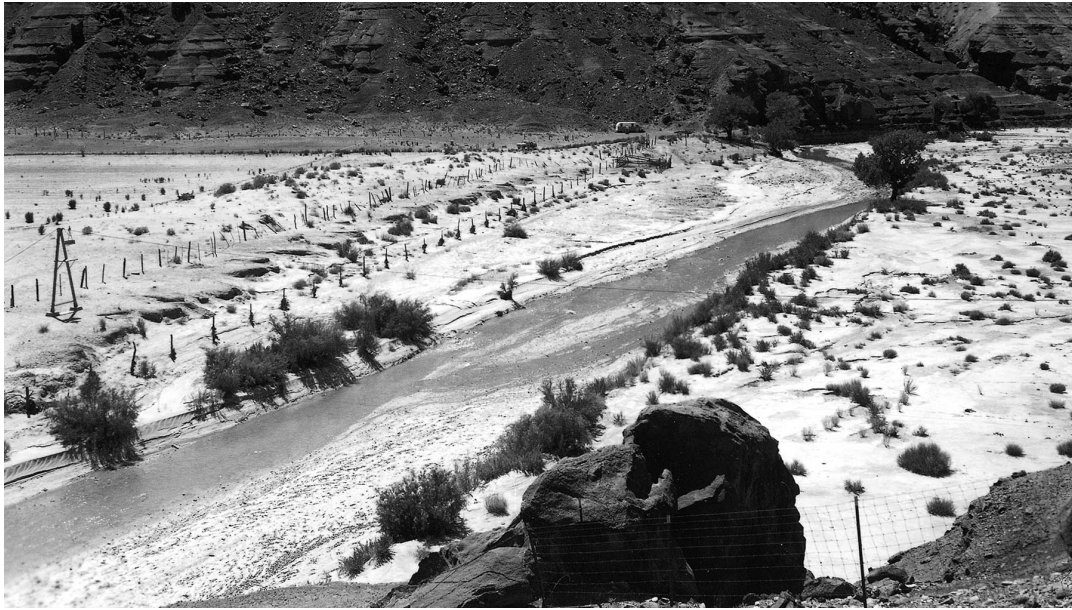
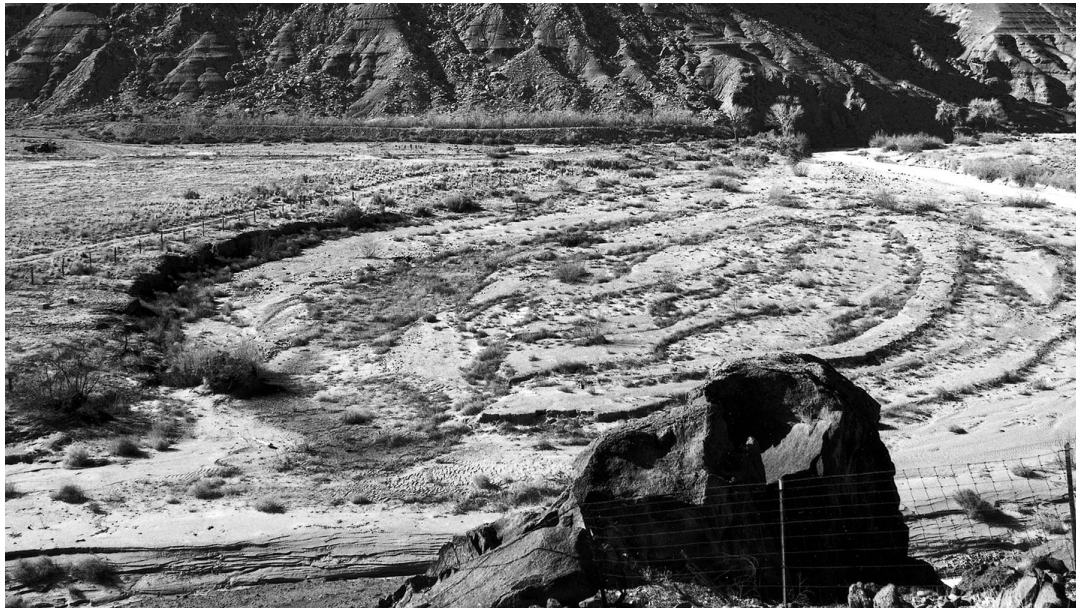
Photograph site 5. View upstream

ca. 1964–1968. This upstream view shows channel conditions in the reach just west of the gaging station. A small cottonwood tree appears at right center, just right of a relatively straight channel reach that undoubtedly was used for indirect-discharge estimates. The metal A-frame at left is the channel-left anchor for a cableway that allowed discharge measurements at flows higher than can be safely waded. The shrubs on both sides of the river are tamarisk. (*Photographer unknown, courtesy of the U.S. Geological Survey.*) **January 19, 1984.** Although the camera is a little too close to the foreground boulder, making this an inexact match, there is no doubt that the channel of the Paria River has changed. The cottonwood tree has been eliminated, probably during one of the floods that have swept down the Paria River since the original photograph. The numerous berms on the modern terrace (unit mt) and steep cutbank on the prehistoric terrace (unit pt; river right) formed during floods in 1980. (*Photograph by Richard Hereford, U.S. Geological Survey, Stake 1379.*)

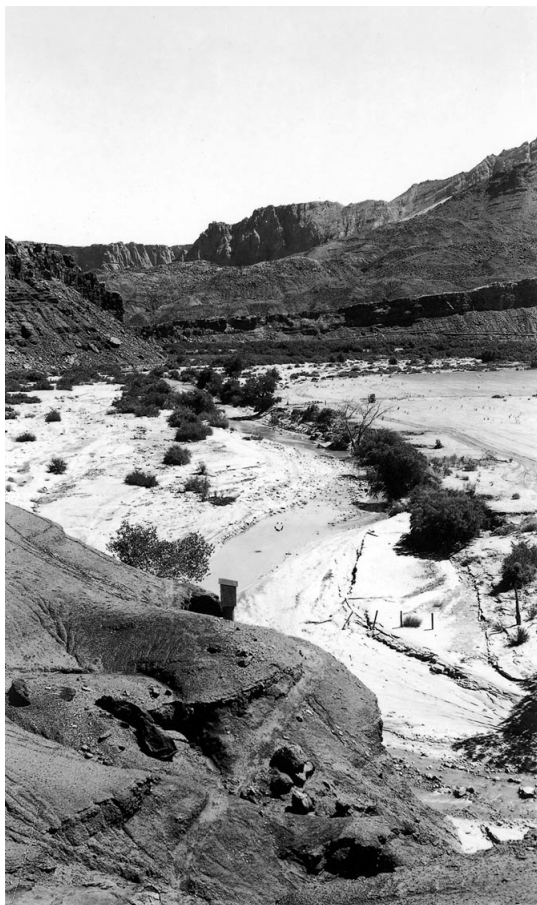
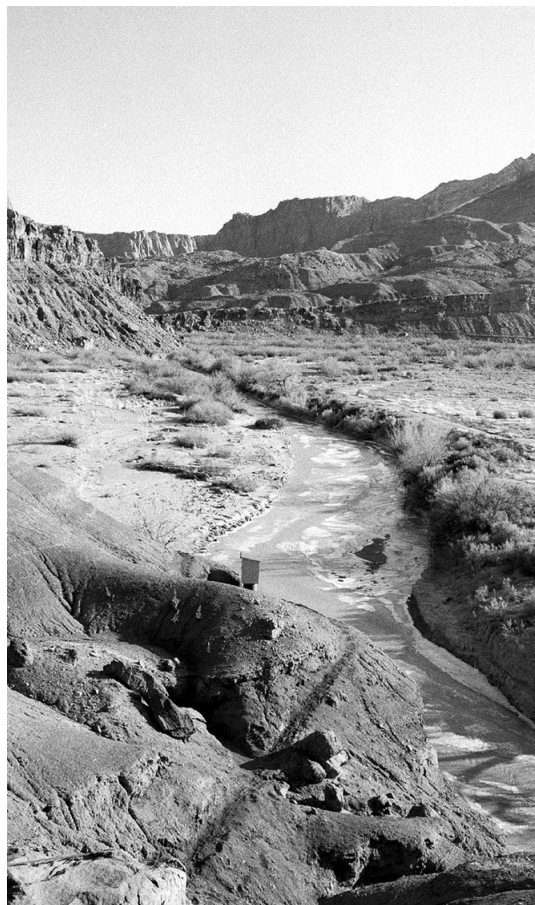
Photograph site 5. View downstream

ca. 1964–1968. As part of routine gaging station maintenance, a hydrologic-technician took this downstream photograph from a point above and just upstream of the gaging station. The gage house and the top of the stilling well are visible at left center. The modern floodplain is relatively open at this time and the channel banks are smooth with gradual slopes. (*Photographer unknown, courtesy of the U.S. Geological Survey.*) **January 19, 1984.** The modern terrace (unit mt) dominates this view. The camera station is a little to the left of the original, nonetheless several significant changes are visible in a minimum of 16 years between the photographs. A small cottonwood has died; the dead branches are barely visible. Tamarisk and willow have increased along the channel margin, particularly on the right side. The channel has also widened slightly and the former floodplain was scoured on river right across from the gaging station during floods of 1980, producing a near-vertical bank. (*Photograph by Richard Hereford, U.S. Geological Survey, Stake 1381.*)

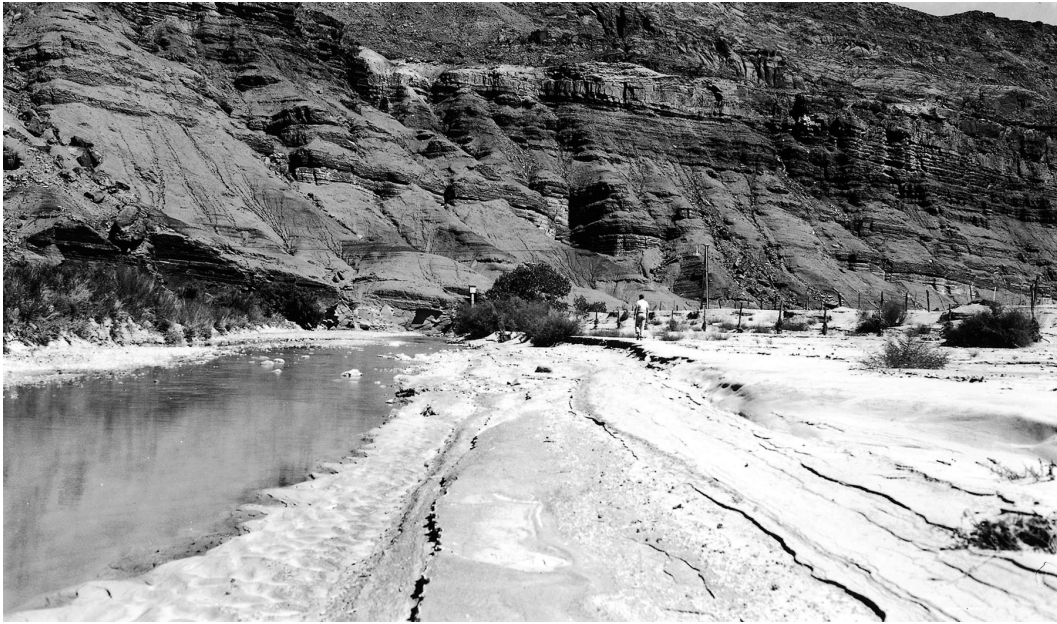
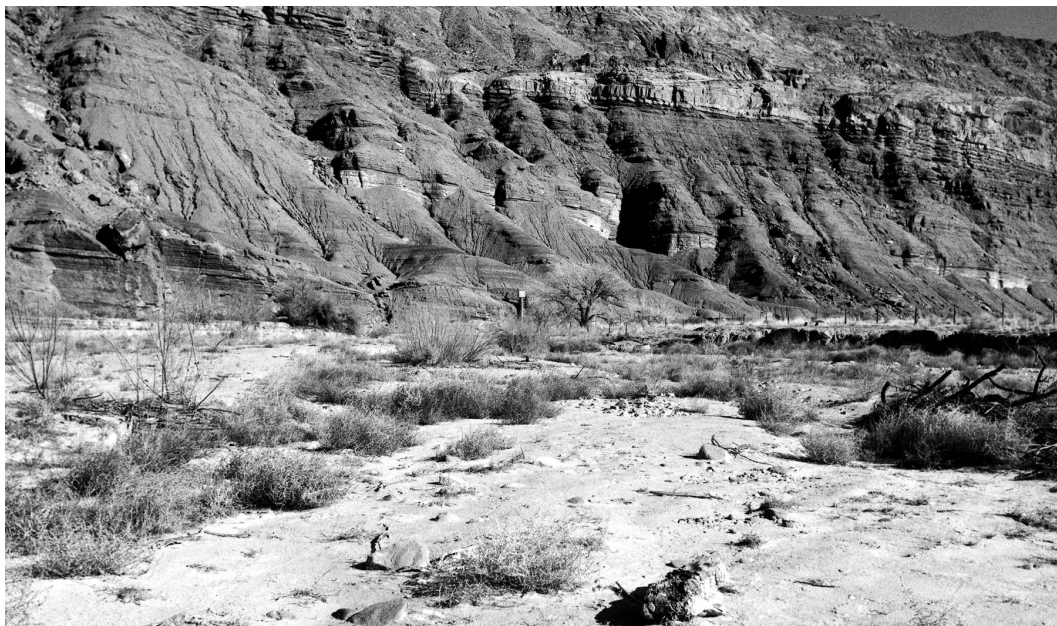
Photograph site 6.

ca. 1964–1968. Operation of a gaging station requires establishment of topographical control in nearby straight, relatively uniform reach to allow indirect-discharge estimates. This downstream view to the south is such a reach. Although we have no evidence to support the exact date of the photograph, we speculate that it was taken in September 1963 after a relatively large flood. The purpose of the photograph was probably to document channel-roughness estimates for the right bank. (*Photographer unknown, courtesy of the U.S. Geological Survey.*) **January 19, 1984.** At least 16 years later (and probably 21 years later), vegetation has grown on the scoured surface of the modern terrace (unit mt) and the channel has shifted towards the left. Almost all the vegetation in the foreground is non-native, including Russian thistle (*Salsola iberica*) in the foreground and tamarisk at left and center midground. Compare these photographs with photograph site 7, which is closer to the gaging station. (*Photograph by Richard Hereford, U.S. Geological Survey, Stake 1382b.*)

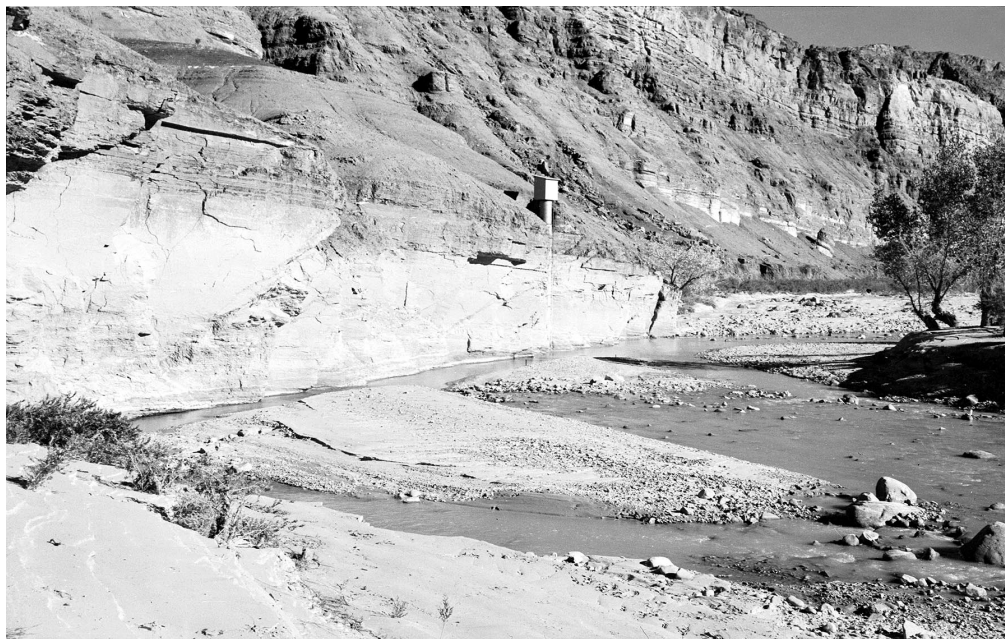
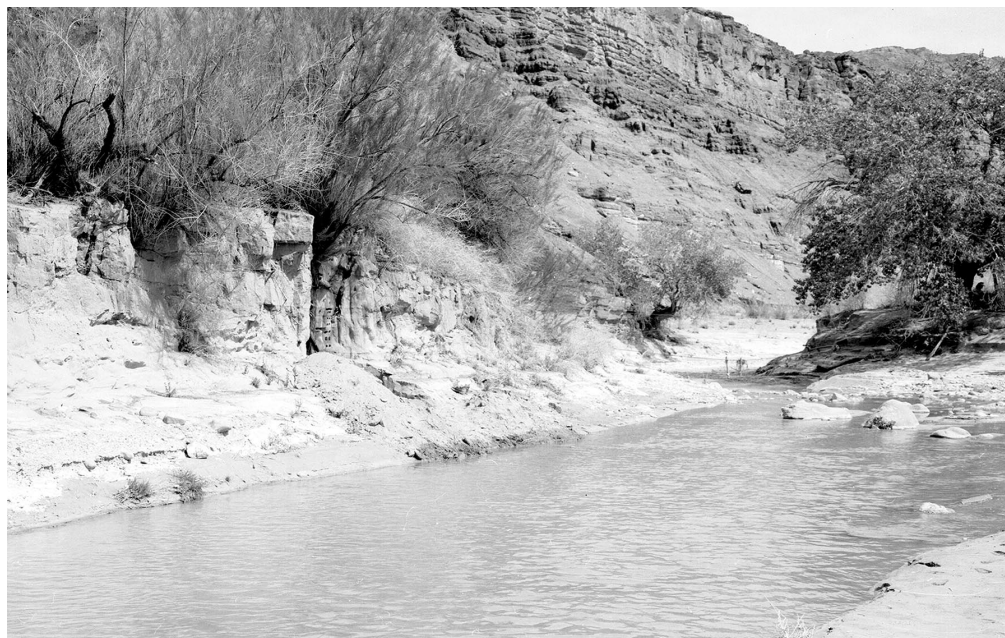
Photograph site 7.

October 1939. The Paria River gaging station was in a barren reach in 1939. This downstream view was taken to document channel conditions, which were needed to make indirect discharge estimates. Small cottonwoods appear on right side of the channel (right midground). (*Photograph by W.T. Stuart, Stake 2679, courtesy of the U.S. Geological Survey.*) **April 19, 1991.** The gaging station is not visible, owing to deposition of 3–4 m of modern alluvium. Hereford (1986) discusses this site. Deposition of this sediment began after 1939, the year of the original photograph. The channel has narrowed considerably and then deepened after the floods of 1980 (table 2 on map sheet). One of the cottonwoods is still present and the tamarisk are rooted in the modern alluvium. (*Photograph by Sara Light, Stake 1781.*)

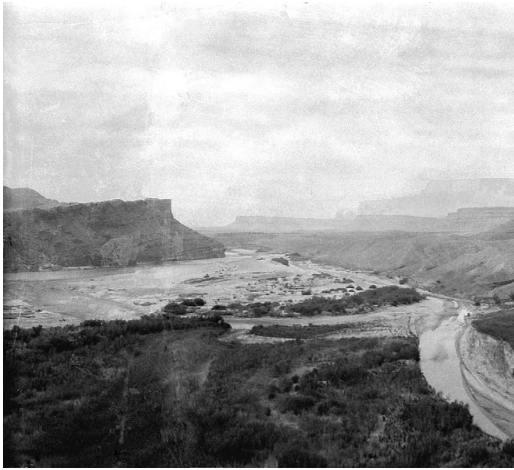
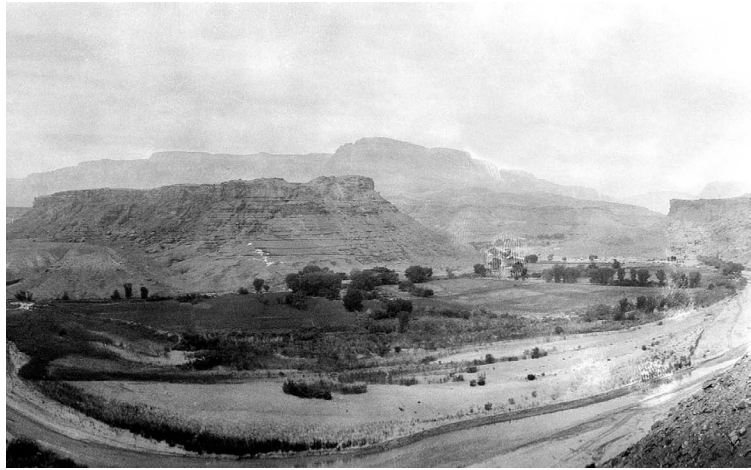
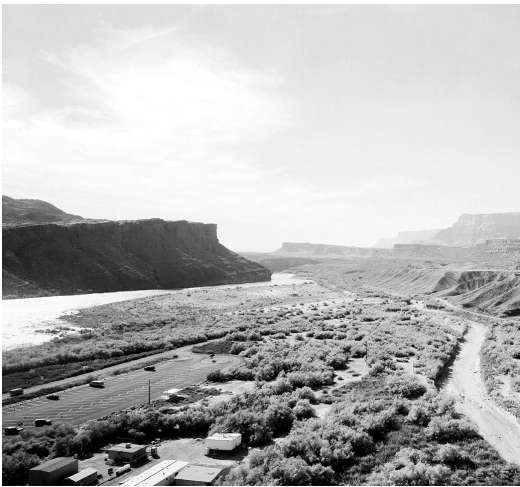
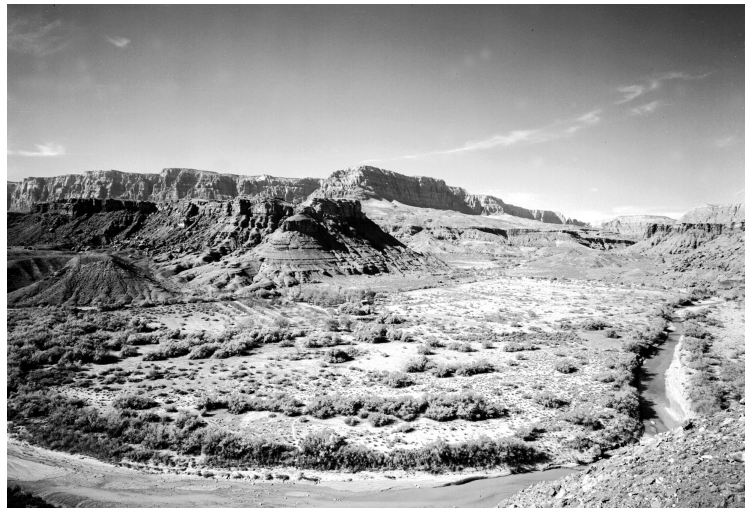
Photograph site 8.

September 1, 1915. Eugene C. LaRue used panoramic cameras to document the rivers he studied. LaRue photographed much of the Green and Colorado River systems between 1914 and 1923. He wanted to build a large dam on the Colorado River about 5 mi upstream from this site; he died seven years before the Colorado River Storage Project, with Glen Canyon Dam as its flagship, was enacted by Congress in 1956. This southwest-facing panoramic vista across Lonely Dell Ranch and the Paria River delta shows detailed conditions of the site in 1915, only three years after the mouth of the Paria shifted downstream below the delta. This avulsion (documented in Herbert E. Gregory's June 5, 1915 photograph, photograph site 11) was caused by the Colorado River flood of the previous spring and is prominent in the view *A* midground. The Paria River, which flows from right to left, has a broad, nearly denuded channel in the view *B* foreground. Vertical banks mark its right bank at lower right. (*Photograph by Eugene C. LaRue, 299, courtesy of the U.S. Geological Survey Photographic Library.*) **November 11, 1999.** Many geomorphic and ecologic changes are apparent in this comparison. First, the Paria River has narrowed its channel considerably because of deposition of the modern alluvium. Possibly in response to this deposition, the channel appears to be deeper than in 1915. The center of the channel has shifted slightly to the left, and riparian vegetation has encroached on the formerly wide channel, filling in the formerly denuded (view *B*) terrace, which is the historic terrace (unit ht). The riparian vegetation has changed from mostly willow and arrowweed to dense growths of tamarisk with willow along the channel margin. (*Photograph by Dominic Oldershaw, Stake 3990.*)

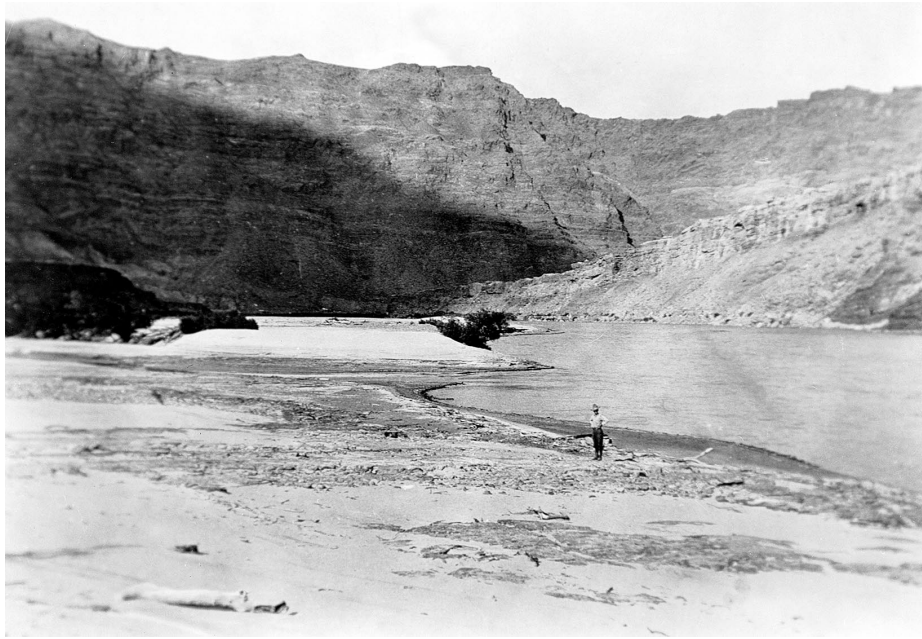
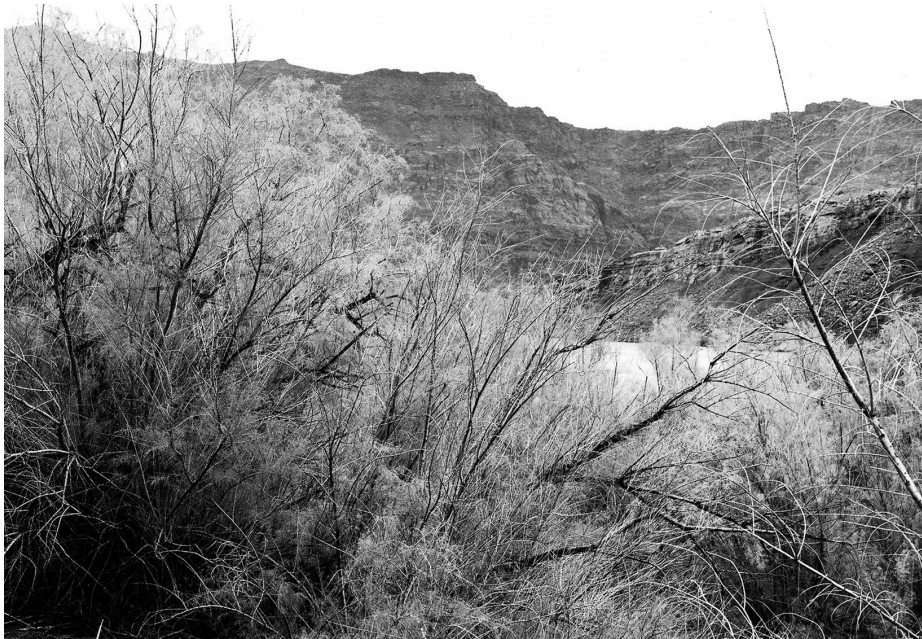
Photograph site 9.

1923. Just before the start of a Grand Canyon expedition in August 1923, LaRue captured this northeast-facing view of the mouth of the Paria River to demonstrate low flow conditions. Large sandbars mantle the north bank of the Colorado River and the riparian vegetation in the distance is probably seep willow. (*Photograph by Eugene C. LaRue, 328, courtesy of the U.S. Geological Survey Photographic Library.*) **December 30, 1991.** Tamarisk now blocks the view. Tamarisk was introduced into the Paria River basin in 1870 by George Adair, who planted cuttings in Adairville, 50 km upstream of the Lonely Dell area. As noted in a biological survey, tamarisk was present but uncommon in 1938 at Lees Ferry. After closure of Glen Canyon Dam in 1963, tamarisk increased dramatically at Lees Ferry. (*Photograph by Jim Hasbargen, Stake 2069.*)

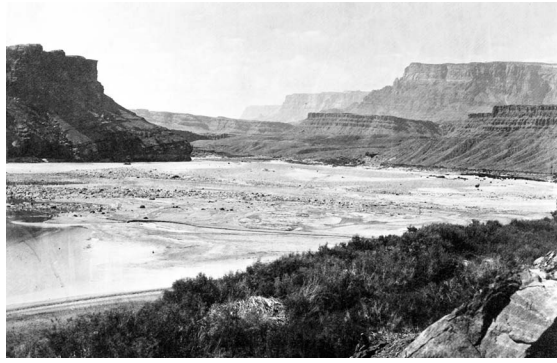
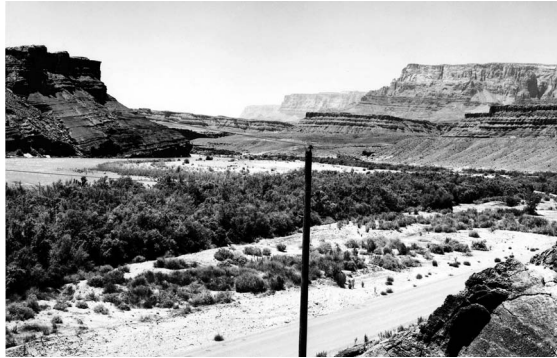
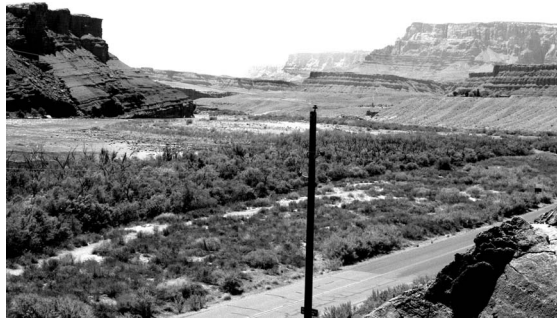
Photograph site 10.

1873. Timothy O’Sullivan was the photographer for the Wheeler Expedition in 1871 and 1873, with Bell filling the position in 1872. After an overland trip to Lees Ferry from Canyon de Chelly, O’Sullivan photographed the Colorado River and Paria River delta at Lees Ferry. This view, looking southwest down the Colorado River at the Paria Riffle and delta, shows the very wide channel of the river that is devoid of riparian vegetation. The vegetation present in the foreground, which is most likely arrowweed, is on what was then the floodplain of the intermediate terrace (unit it). Note the piles of driftwood among the foreground plants. (*Photograph by Timothy H. O’Sullivan, 339, courtesy of the National Archives.*)

June 27, 1972. A road to the boat-launching ramp at Lees Ferry crosses the intermediate terrace (unit it) in the foreground. A lower cable, shown over the water at the extreme left, is for the gaging station on the Colorado River at Lees Ferry. In his interpretation (Turner and Karpiscak, 1980), Turner noted the conversion from native vegetation, which he interpreted as “probably rabbitbrush (*Chrysothamnus* sp.),” to a mixture of seep willow, arrowweed, and tamarisk. The tamarisk is on the topographically lower terrace of the pre-dam alluvium (unit pda). (*Photograph by Raymond M. Turner, U.S. Geological Survey, Stake 671.*) **May 6, 1994.** The density of low shrubs on the intermediate terrace (unit it) has increased considerably, probably in response to less disturbance associated with the road. A fire swept through the dense tamarisk at left in the early 1980s, leaving many dead trees. Unfortunately, tamarisk responds positively to fire, and most of the re-growth shown is tamarisk. The formerly prominent delta is now difficult to see because of the dense tamarisk grove on its surface and the higher banks. (*Photograph by Dominic Oldershaw, Stake 671.*)

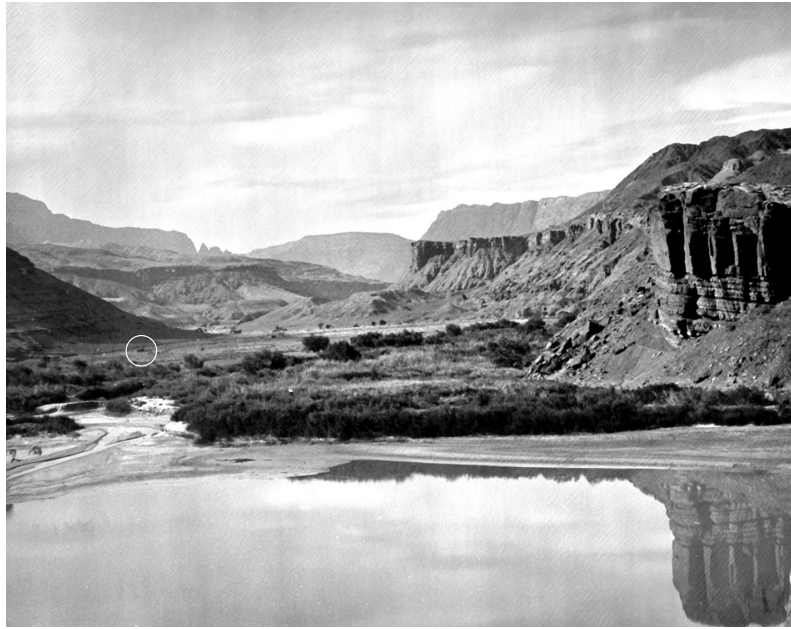
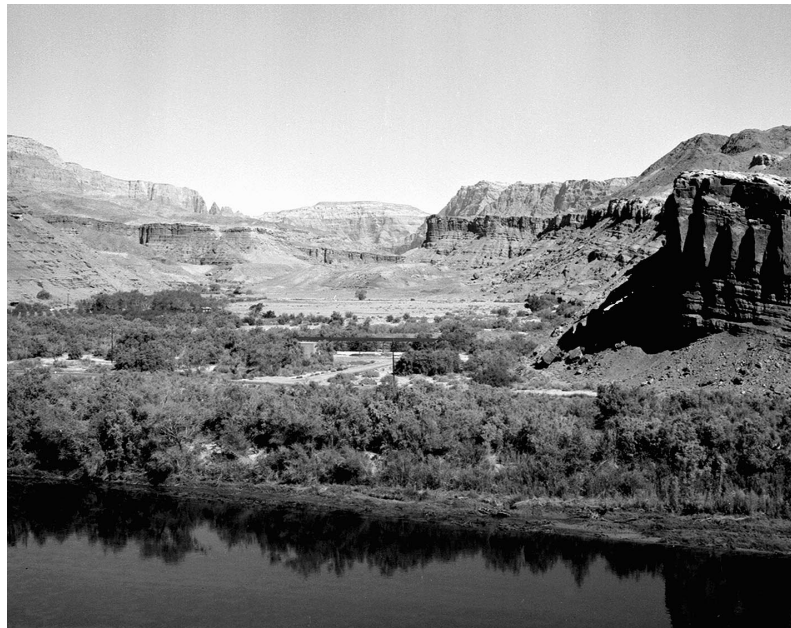
Photograph site 11.

1873. Timothy O'Sullivan, in one of his most famous photographs, documented the mouth of the Paria River in 1873. This view looking north-northwest into Paria River Canyon shows scattered cottonwood and willow in the channel of the Paria River (Turner and Karpiscak, 1980) growing on what was then the intermediate-age floodplain of the Colorado River. John D. Lee's cabin appears in the midground at the left (circle). (*Photograph by Timothy H. O'Sullivan, 348, courtesy of the National Archives.*) **August 22, 1972.** About 1912, the mouth of the Paria River shifted downstream to below the delta, and the former mouth filled in with sediment, mostly from the Colorado River. The vegetation is mainly tamarisk and seep willow. John D. Lee's former ranch supports a luxuriant growth of cultivated cottonwood and fruit trees. (*Photograph by Raymond M. Turner, U.S. Geological Survey, Stake 706.*)

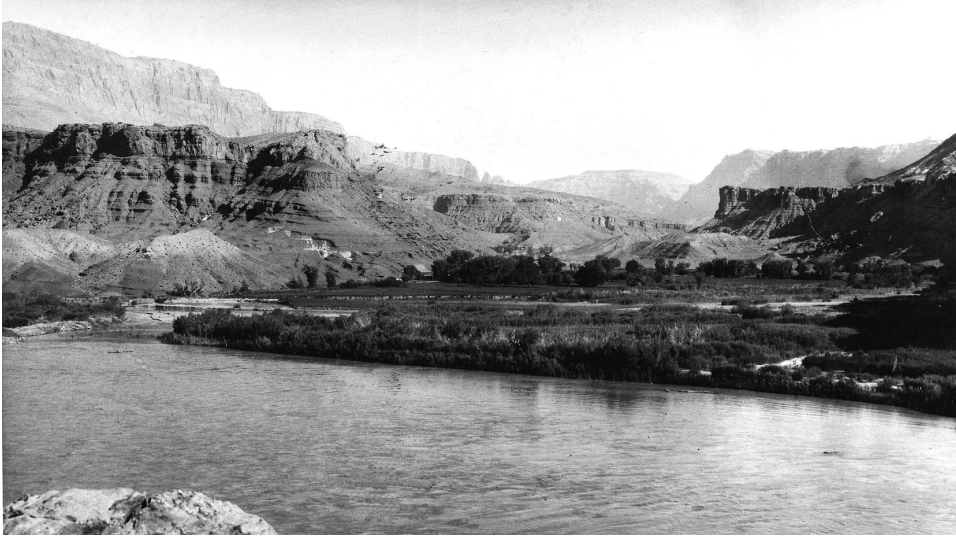
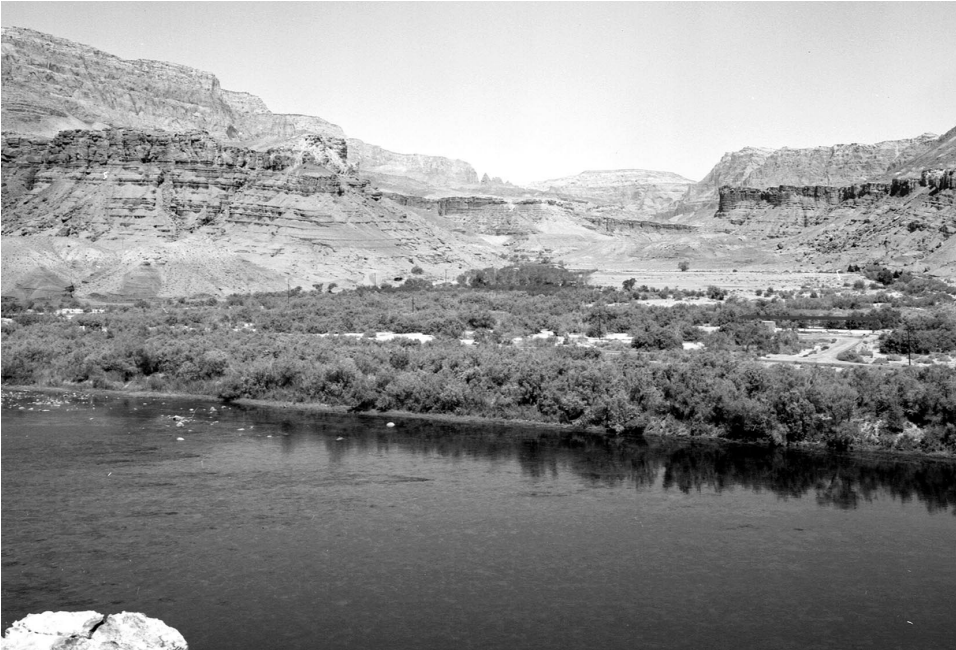
Photograph site 11.—Continued

June 5, 1915. Herbert E. Gregory, a pioneering geologist in the region, came to Lees Ferry as a part of a survey of the Paria River basin. As his predecessors did, Gregory took a photograph (facing west-northwest) of the mouth of the Paria River and Lonely Dell Ranch. The Colorado River, in full flood, has carved a channel through the delta and into the channel of the Paria River, which had only shifted downstream three years before Gregory's visit. The vegetation is mostly seep willow and arrowweed, with cottonwood trees around Lonely Dell and upstream on the Paria River. (*Photograph by Herbert E. Gregory, 285, courtesy of the U.S. Geological Survey Photographic Library.*) **August 22, 1972.** The Colorado River no longer floods as frequently as it did in the period when Gregory visited. Glen Canyon Dam, which closed its gates nine years before this photograph was taken, greatly affected the Colorado River. One of the largest changes has been the increase in riparian vegetation along the margin of the river; in this scene, non-native tamarisk has replaced the native willows and arrowweed. (*Photograph by Raymond M. Turner, U.S. Geological Survey, Stake 708a.*)
